# The effect of impact damage on materials

**Ashley Morris**

BEng (Hons) Mechanical Engineering

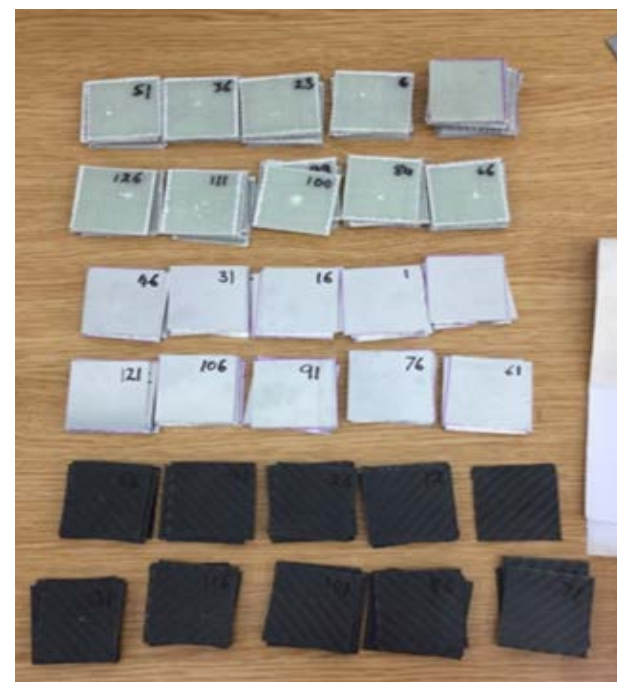
Images of all of the test samples, these include the damage and undamaged test samples.

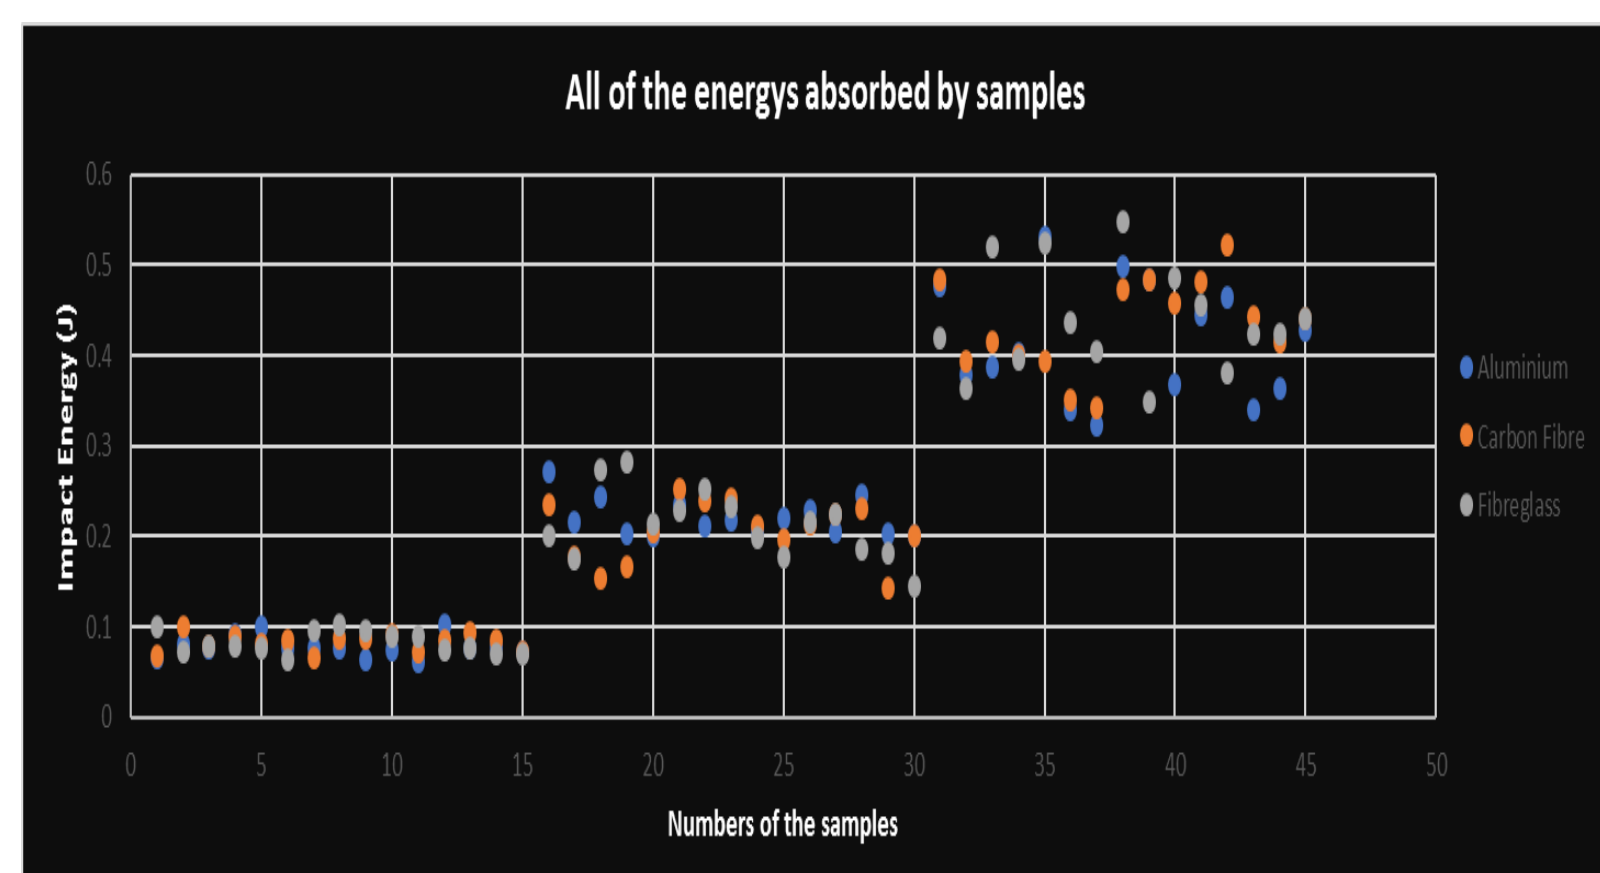
Each test sample and their impact energy that was absorbed by the part.

The results from the LDV testing showed that carbon fibre and fibreglass were affected by the experiment with drops in stiffness for both materials, both materials also saw a decline in stiffness as the impact energy increased, this is what was expected and predicted at the beginning of the investigation. The aluminium samples on average did not show any loss of stiffness from the experiment, as found in the analysis this might be caused by the face of the projectile that makes contact with the test sample, that significantly affects the damage that the aluminium receives.
